APPLIED INFORMATION TECHNOLOGY ON REMOTE SENSING DATA INVESTIGATION OF RED MUD CATASTROPHE

J. Berke – V. Kozma-Bognár – L. D. Kováts – P. Burai – T. Tomor – T. Nagy – T. Németh

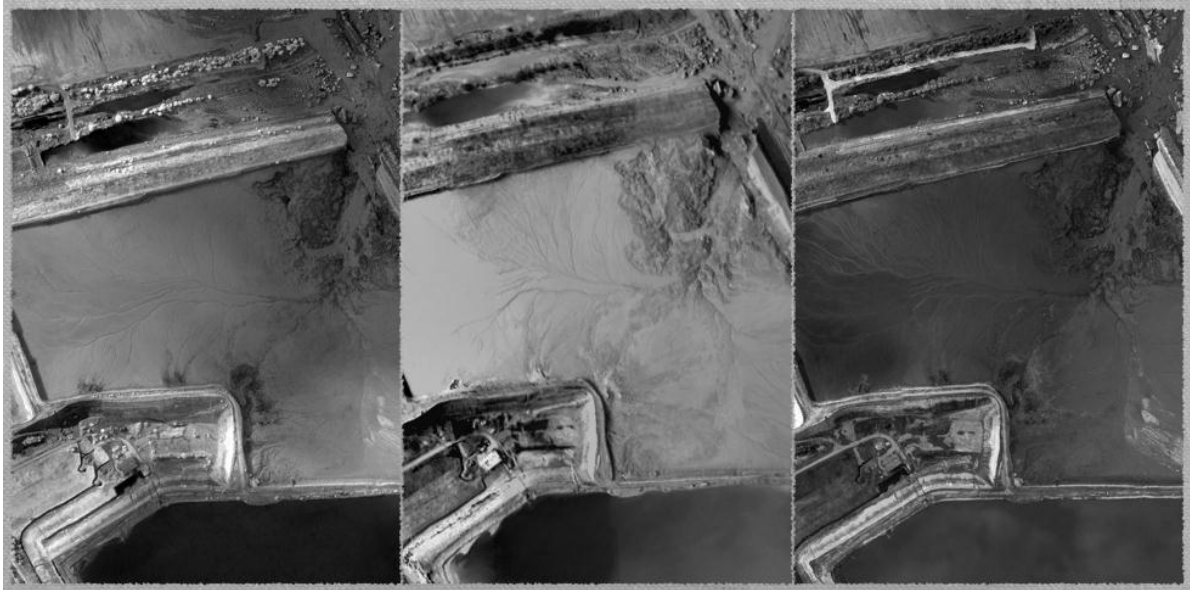
Figure 1.
Main type of images of data collection with the help of air-shot
Near Infrared (NIR, left), Far Infrared (FIR, middle) and Visible (VIS, right)

processing the different remote-sensing technologies and to the collection of data corresponding both short and long term processing goals. Figure 1. shows basic data about the images gathered during our flights and air-shots. Before the assessment of images the necessary pre-processing tasks had been carried out: synchronization in time and place, filtration of optical and sensor-made noise, radiometric and geometric correction. During the processing of data we partly used our innovative programs (Spectral Fractal Dimension (SFD) based processing [2], [16], processing of FIR images [8]), and also special GIS and image processing software (ITT ENVI, Specim CaliGeo, Erdas Imagine, ESRI ArcGIS).

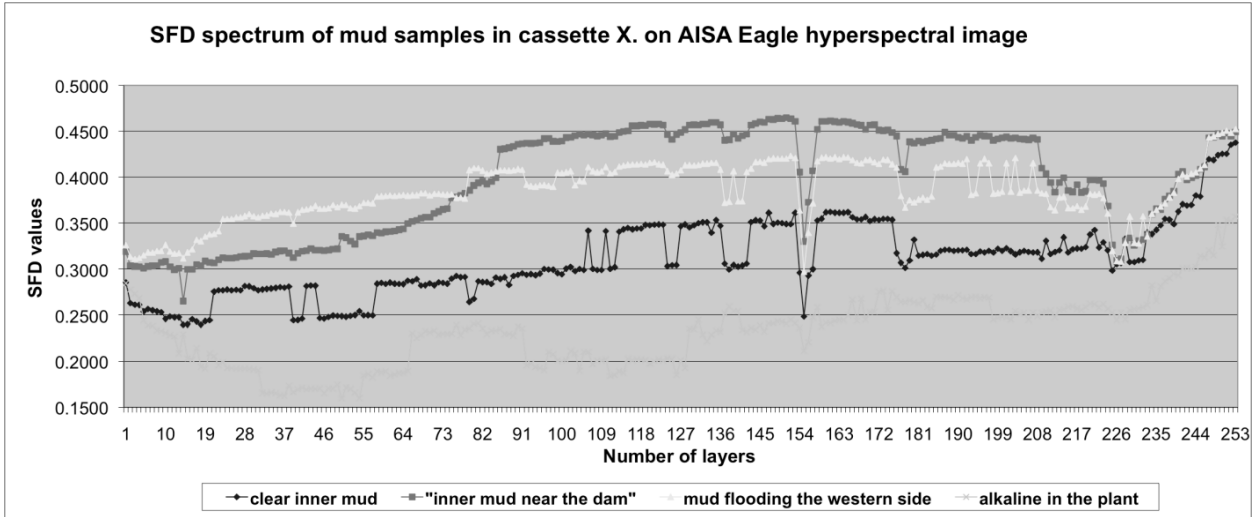
Figure 2.

'Spectral fractal fingerprints' of mud samples in the plant /Spectral Fractal Dimension values based on hyperspectral image data/

The evaluation of data provided by different remote sensing technologies was carried out in parallel, in consideration of the seriousness of the situation, applying unique and integrated data processing methods. With the help of our own method based on the fractal system we identified the noisy bands, the optimal image bands from among the hyperspectral, VIS, NIR and FIR images [9], [10], and also the muddy areas based on Spectral Fractal Dimension curves [2], [3], (Figure 2.).

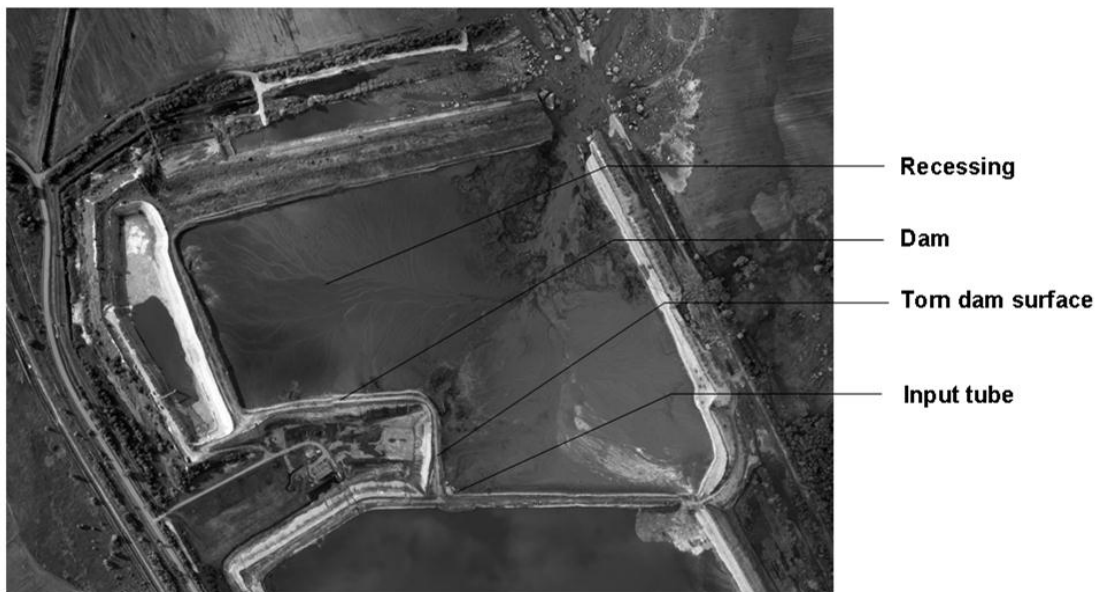
Figure 3.

Localization of cracks, breaks and slivering

Based on the air-shots we have defined the movements involving the Northern wall of the dam together with their causes and we have localized the cut-off points and the slivering of the wall (Figure 3.), [4].

We have identified the wet, leaking areas in the images shot near the reservoir. During the lateral examination of the dam wall we studied clues alluding to cracks and leaks.

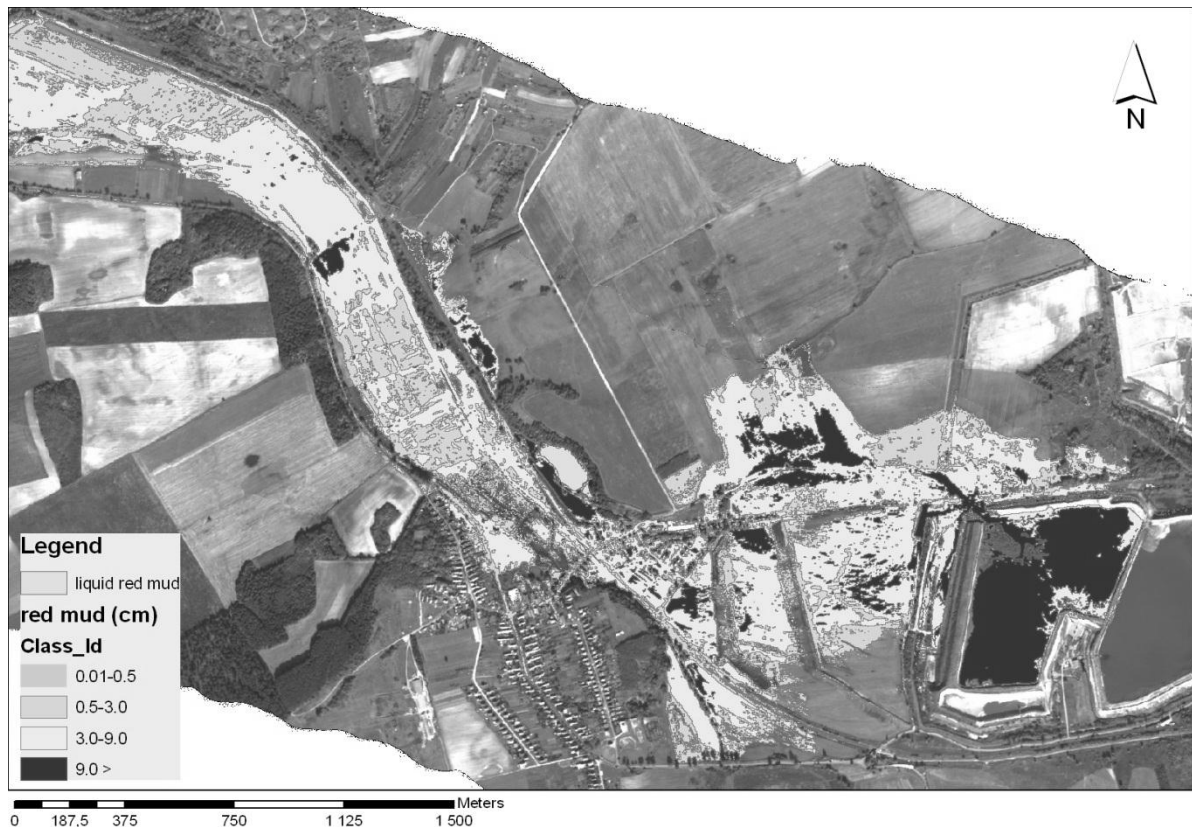
Figure 4.
Hyperspectral mosaic (RGB) and areas covered by layers of different thickness

The volume between the two areas was defined by their intersection. The 'reconstruction' of the broken piece of wall was also made based on the shots above. We have also defined the cross-section and longitudinal section of the reservoir [4]. We applied different classes (end members) according to the surface cover. The wet phase, with dry matter content less than 30%, was defined separately. When applying the SAM, the angle value was optimized based on the control areas. After the area impoundment we defined the spectra correlating with the thickness of mud (in case of a mud with 30-70 percent by mass) with the help of regression analysis, based on on-the-spot samples. Based on the RMLI (Red Mud Layer Index) calculation from the 550 nm and the 682 nm band cassette we defined the threshold values for 4 thickness categories of previously marked areas (Figure 4.), [4].
